- PINE BLUFF HIGH SCHOOL CAMPUS TOPOGRAPHIC SURVEY, MARCH, 1973.

Stormwater Management
System

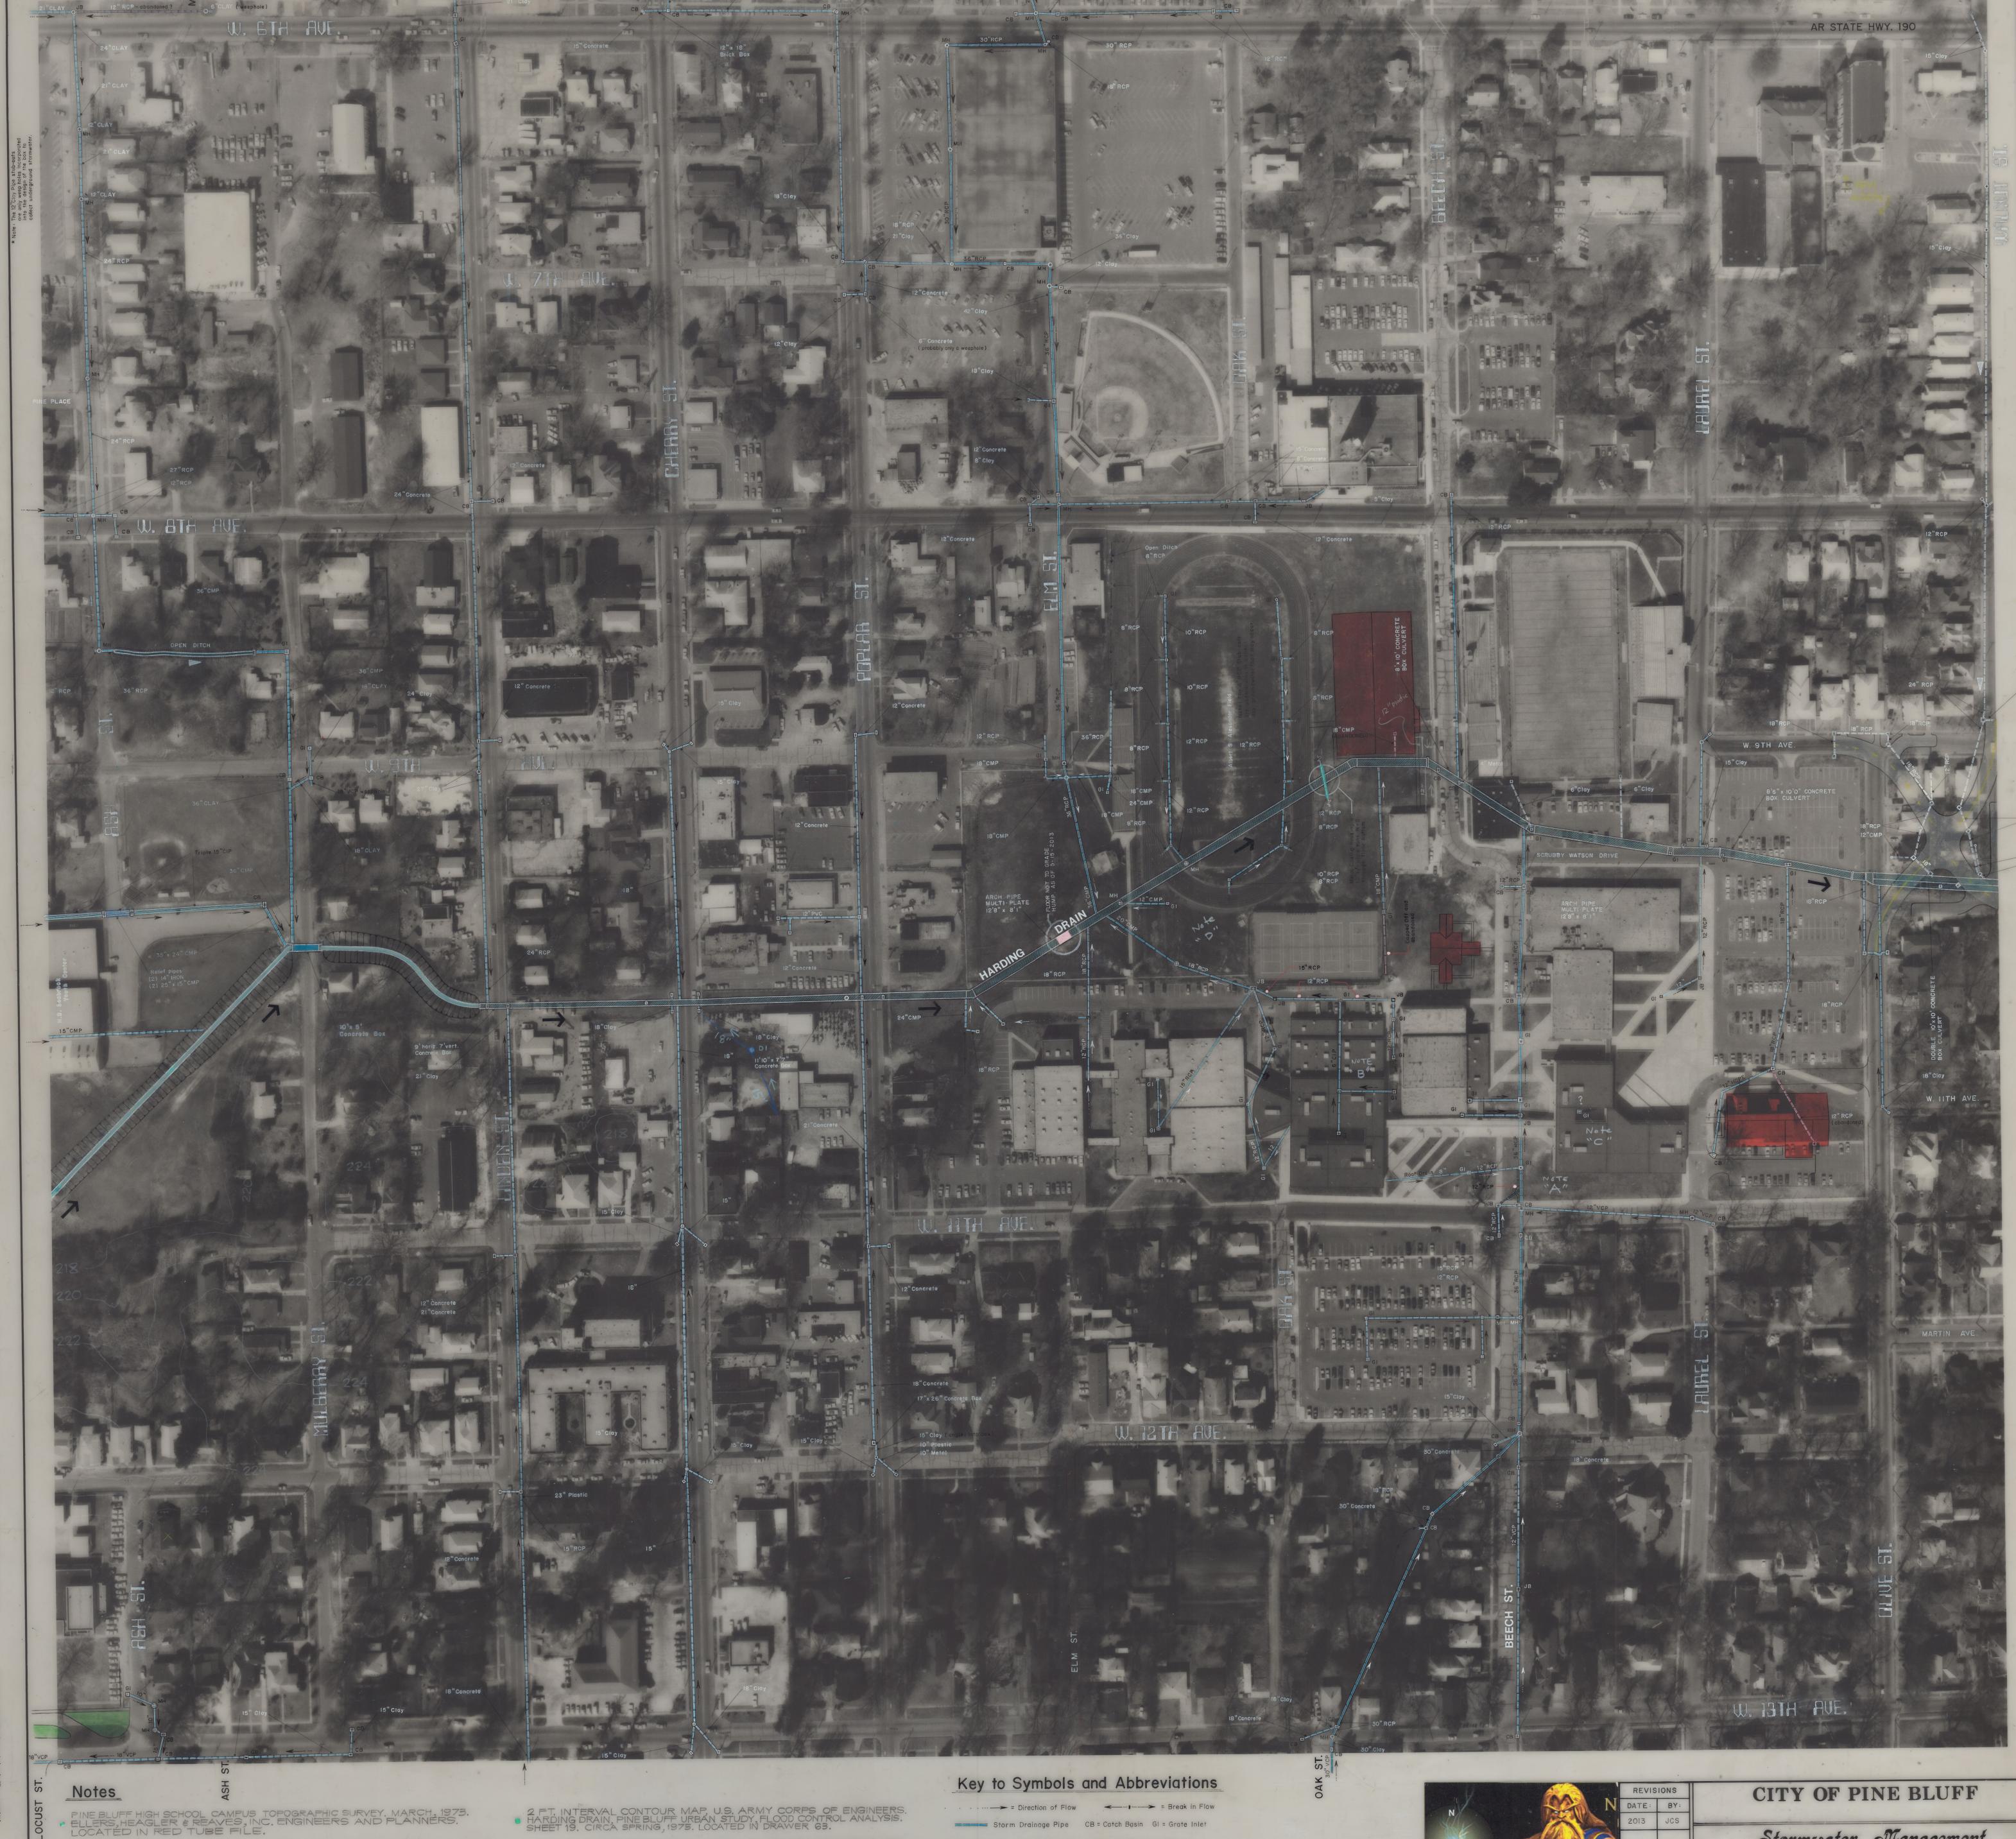
unearthed while repairing a cave in along the 36"RCP in 2013. All three lines are active.

- Just what happened here. I cannot say. Note B. Unverified. Perhaps a more astate surveyor than myself should define

Note C. - unverlied. Roof Drains were beyond the scope of this survey.

Note D. - In the spring of 2013, street Department personell entered the main trunk line of Harding Drain armed with a measuring tape, flashlights, pencil and paper and made note of all incoming feeder pipes to the main line as it skirted across the track Field.
